Multi-Service IronWare Software R02.7.03a for Brocade BigIron RX Series Switches

Release Notes v1.0

January 14, 2011

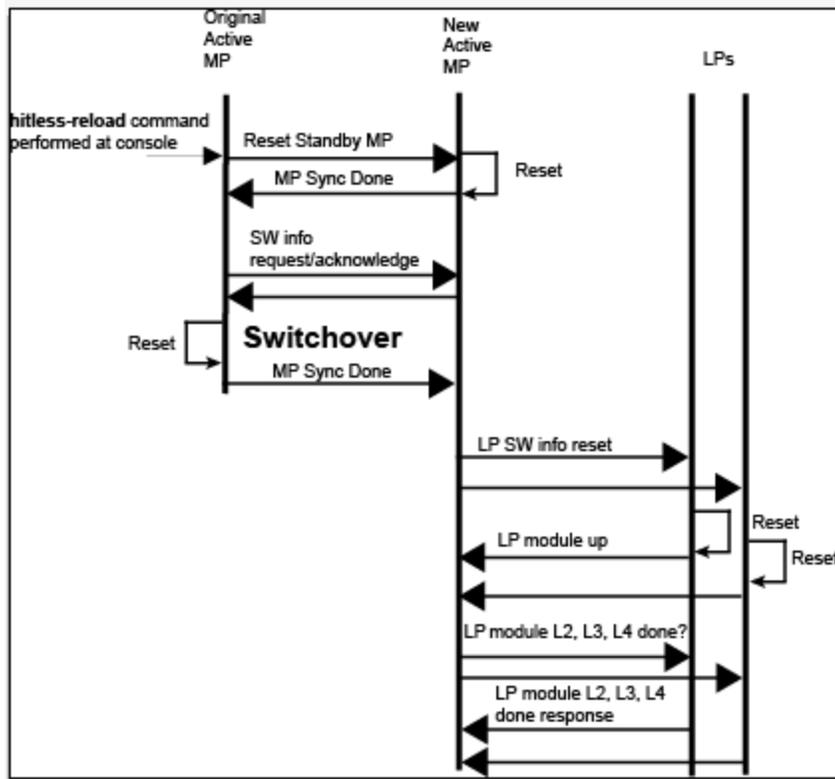
Figure 1 Management module (MP) and Interface Module (LP) Hitless Upgrade Process

Management module (MP) and Interface Module (LP) Hitless Upgrade Process provides a detailed diagram of the Hitless reload process.

- If there are protocol dependencies between neighboring nodes, it's recommended that only each node is upgraded: one node at a time.
- After hitless upgrade, the BigIron RX switch will still have the same running configuration as it does before the upgrade. A configuration that is not saved before hitless reload is not removed and the existing startup configuration does not take effect. This behavior is the same as displayed by the management module switchover feature.

Hitless Layer 2 OS upgrade is executed at the active management module. During the process of upgrading the image, control of the switch is shifted to the standby management module. For this reason, you need to have management sessions enabled on both the active and the standby management modules. When the reload is complete, the management module that was in the standby condition at the beginning will be in the active state. If you want the original management module to be active, you must manually
