Emulex[®] Drivers for VMware ESXi for LightPulse[®] Adapters

User Guide
Release 12.0

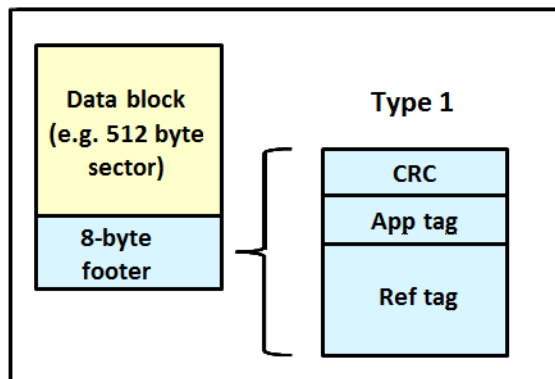
Figure 1: Data Block Showing Type 1 DIF

The following figure shows a data block (with a 512-byte sector) with the 8-byte footer attached to the end. The contents of the 8-byte footer are shown with the fields that make up the Type 1 DIF; the Guard Tag, the App Tag, and the Ref Tag. The App Tag is not used by the `lpfc` driver.

When data is written, the DIF is generated by the Host, or by the adapter, based on the block data and the logical block address. The DIF field is added to the end of each data block, and the data is sent through the SAN to the storage target. The storage target validates the CRC and Ref tag and, if correct, stores both the data block and DIF on the physical media. If the CRC does not match the data, then the data was corrupted during the write. A Check Condition is returned back to the host with the appropriate error code. The host records the error and retransmits the data to the target. In this way, data corruption is detected immediately on a write and never committed to the physical media. On a read, the DIF is returned along with the data block to the host, which validates the CRC and Ref tags. Because this validation is done by the hardware, it adds a very small amount of latency to the I/O.

The format of the Guard Tag can optionally be an IP Checksum instead of the CRC mandated by T10 DIF. This can be beneficial because the Initiator Host uses less CPU overhead to generate an IP Checksum than it does with a CRC. The IP Checksum is typically passed as the Guard Tag between the Initiator Host and the adapter. The adapter hardware will translate the IP Checksum into a CRC, or vice versa, on data being sent/received on the wire. The CRC is called a DIF protection type, and the IP Checksum is referred to as DIX protection type.

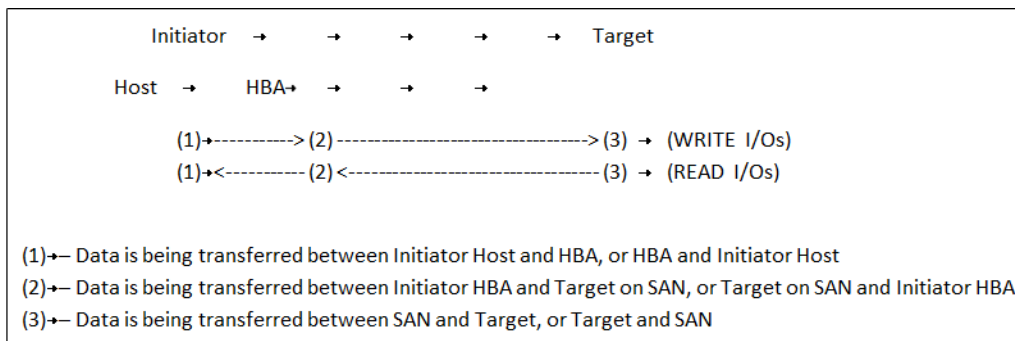
Figure 2: Data Transfer between Initiator Host and the Adapter

In addition, the Initiator Host will also provide the adapter with an operation code that tells the controller how to place the protection data for the type of I/O to perform. Each I/O is logically a two-step process. The data is transferred between the Initiator Host and the adapter (over the `PCI` bus) and between the adapter and the target (over the `SAN`) as shown in the following figure. The type of operation defines whether the data transfer has protection data.
