# Multi-Service IronWare Software R02.7.02a for Brocade BigIron RX Series Switches

Release Notes v1.0

October 2, 2009

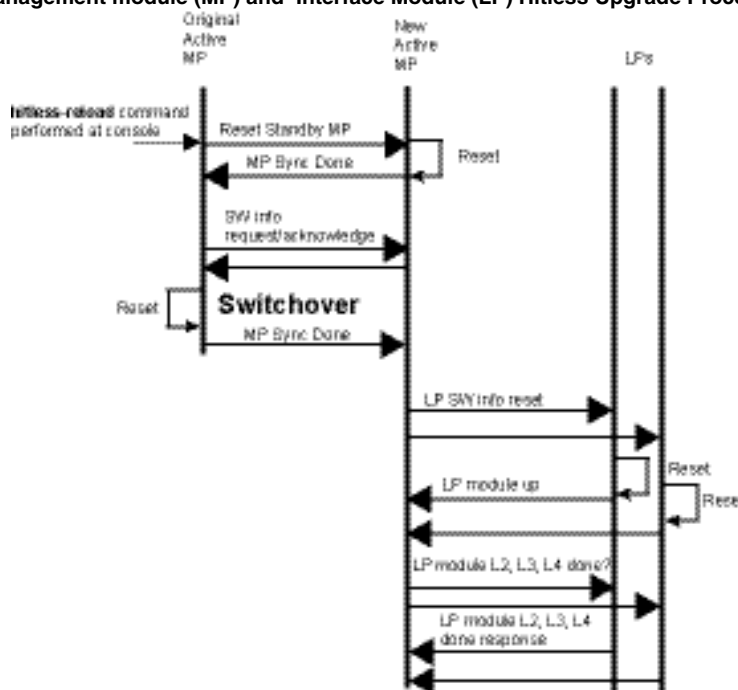
Management module (MP) and Interface Module (LP) Hitless Upgrade Process provides a detailed diagram of the Hitless reload process.

**Figure 1 Management module (MP) and Interface Module (LP) Hitless Upgrade Process**
