Memory Errors and Dell EMC PowerEdge YX4X Server Memory RAS Features

Revision: **1.3** Issue Date: **11/20/2020**

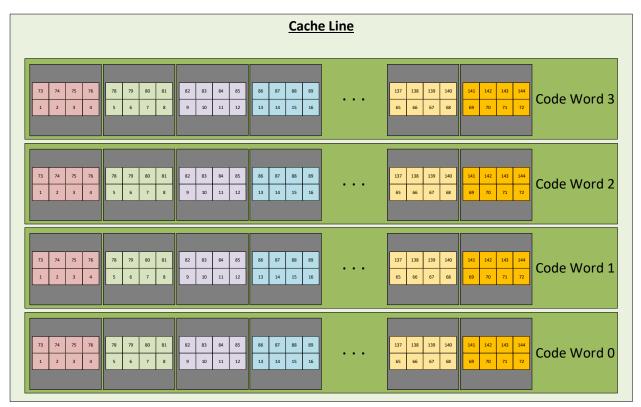
Figure 1 - Example Implementation of 8-Bit Symbol Size Advanced ECC

73	74	75	76	X	X	X	X	82	83	84	85	86	87	88	89		137	138	139	140	14	142	143	144
1	2	3	4	X	X	X	X	9	10	11	12	13	14	15	16	•••	65	66	67	68	69	70	71	72

An example SSC-DSD coding implementation is represented in the following figures where a 64-byte cache line is broken into four code words (Figure 1). Each code word is made up of eighteen 8-bit symbols and can be broken down into 128-bits of data and 16-bits of ECC (8-bits of CRC and 8-bits of parity). The data and ECC is arranged (as shown by the various colors) such that all bits from an entire symbol are located within a single x4 DRAM device. Depending on the SSC-DSD coding implementation, Advanced ECC may correct various combinations of multiple bits error patterns within a single symbol including the entire symbol itself (Figure 2). However, a pair of two single bit errors across two symbols would yield an uncorrectable error (Figure 3).

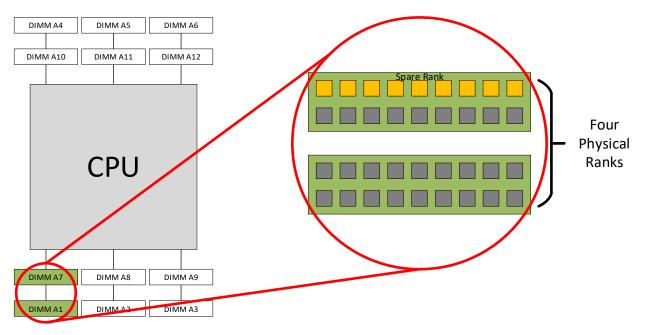
Figure 5 - Example of two 16GB (2Rx8) RDIMMs with one rank held as spare

<u>Memory Rank Sparing</u> is a memory RAS feature available on Intel platforms that will reserve one or more memory ranks per channel as spares for failover. When the PowerEdge server memory health monitor has determined that one of the ranks in a memory channel has degraded, it will trigger rank

sparing failover. The failover process consists of checking the health of the spare rank(s) through <u>patrol</u> <u>scrubbing</u> then seamlessly copy the contents of the degraded rank to the spare rank(s). Memory rank sparing is disabled by default and can be enabled in BIOS setup if required.

In order to support single rank sparing, a system must be populated with at least two memory ranks per memory channel. The memory capacity reduction due to rank sparing is based on the memory configuration (number of ranks per channel and size of ranks). After one failover event has occurred, no further failover can occur in single rank sparing mode.
