# Memory Errors and Dell EMC PowerEdge YX4X Server Memory RAS Features

Revision: **1.1**  
Issue Date: **7/10/2020**

## Introduction

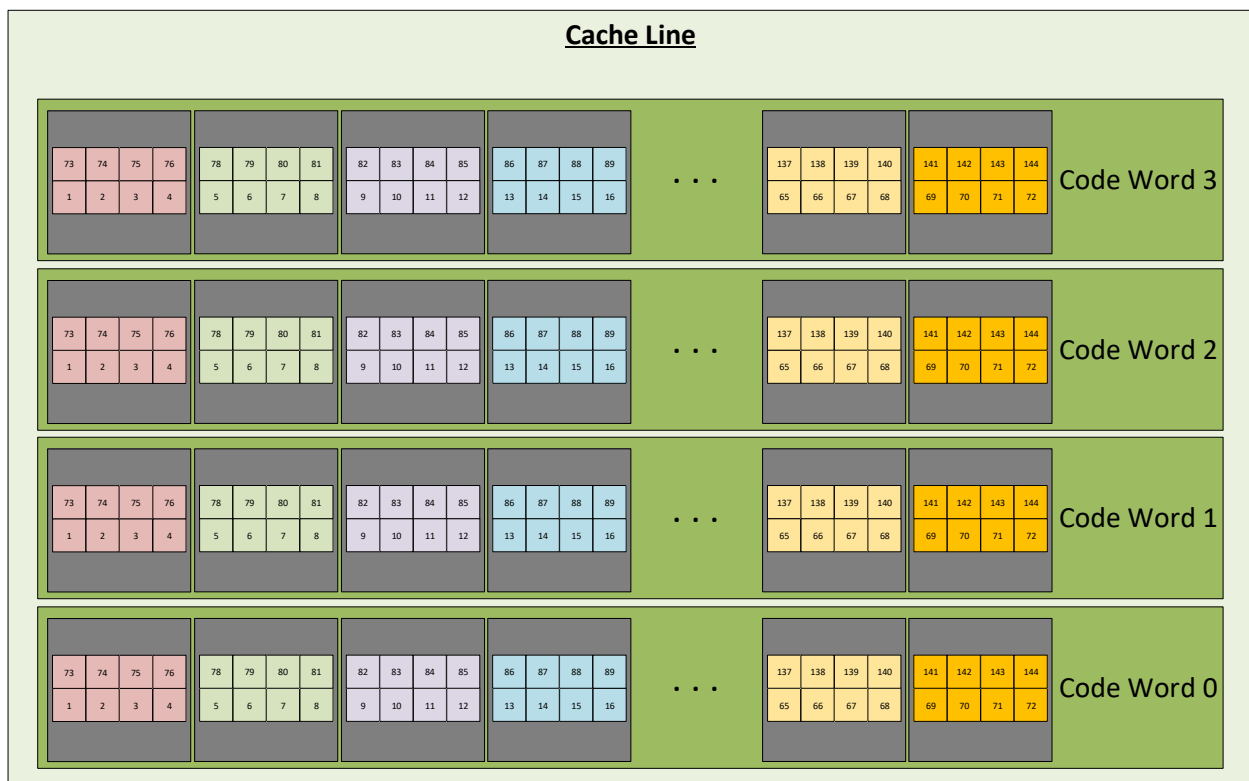
Figure 1 - Example Implementation of 8-Bit Symbol Size Advanced ECC

An example SSC-DSD coding implementation is represented in the following figures where a 64-byte cache line is broken into four code words (Figure 1). Each code word is made up of eighteen 8-bit symbols and can be broken down into 128-bits of data and 16-bits of ECC (8-bits of CRC and 8-bits of parity). The data and ECC is arranged (as shown by the various colors) such that all bits from an entire symbol are located within a single x4 DRAM device. Depending on the SSC-DSD coding implementation, Advanced ECC may correct various combinations of multiple bits error patterns within a single symbol including the entire symbol itself (Figure 2). However, a pair of two single bit errors across two symbols would yield an uncorrectable error (Figure 3).

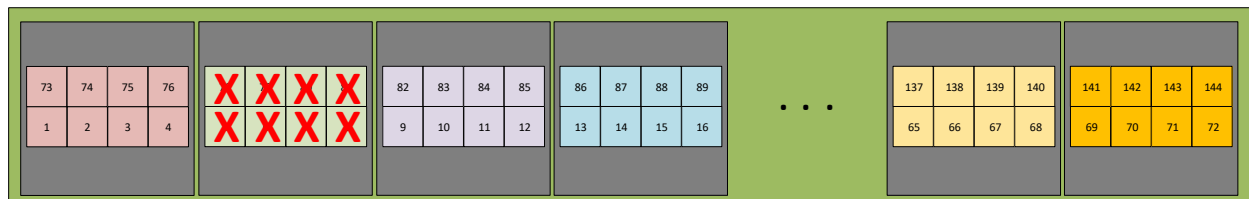
Figure 2 - Advanced ECC can correct multi-bit errors in a single symbol...

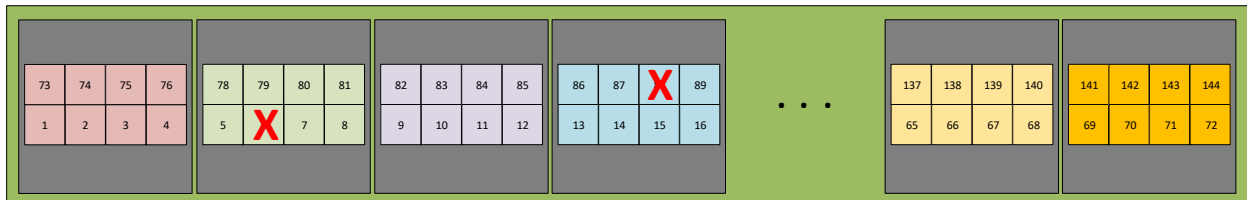
Figure 3 - But Advanced ECC cannot correct errors in multiple symbols

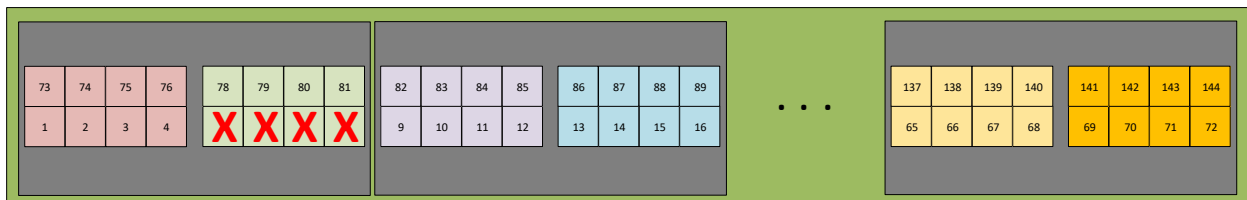
Figure 4 – Advanced ECC with x8 DIMMs allows a nibble per DRAM to be protected but not the entire device

It was earlier mentioned that Advanced ECC, when used in conjunction with x4 DIMMs, may provide error correction to a single DRAM device including failure of the entire device itself. This is achieved by the processor organizing memory accesses such that a given DRAM device is only contributing data to a single symbol – and through SSC-DSD, any one symbol can be fully redundant. On the other hand, DIMMs with x8 DRAM devices will straddle two symbols and may only provide partial device correction at the nibble level. An uncorrectable error will occur should both symbols within a x8 DRAM device experience an error or the entire device fail.

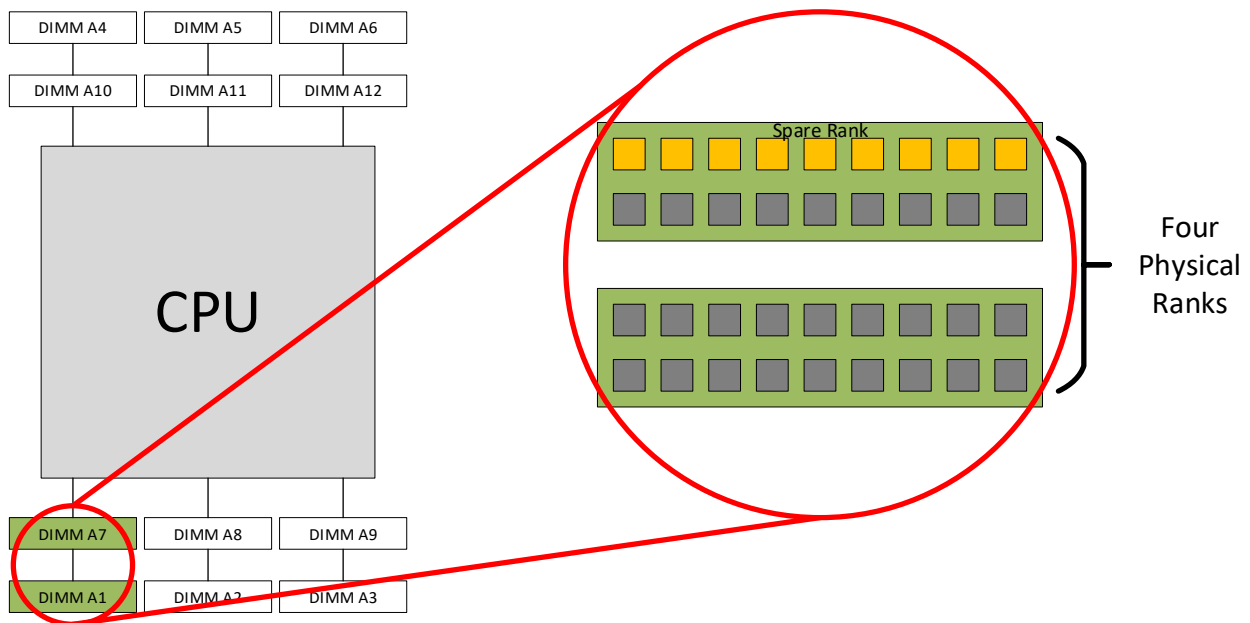
Figure 5 - Example of two 16GB (2Rx8) RDIMMs with one rank held as spare

*Memory Rank Sparing* is a memory RAS feature available on Intel platforms that will reserve one or more memory ranks per channel as spares for failover. When the PowerEdge server memory health monitor has determined that one of the ranks in a memory channel has degraded, it will trigger rank sparing failover. The failover process consists of checking the health of the spare rank(s) through [patrol scrubbing](#) then seamlessly copy the contents of the degraded rank to the spare rank(s). Memory rank sparing is disabled by default and can be enabled in BIOS setup if required.

In order to support single rank sparing, a system must be populated with at least two memory ranks per memory channel. The memory capacity reduction due to rank sparing is based on the memory configuration (number of ranks per channel and size of ranks). After one failover event has occurred, no further failover can occur in single rank sparing mode.

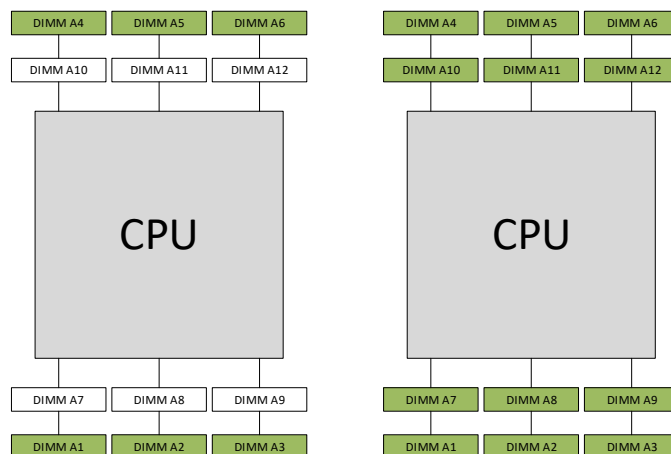
Figure 6 - 6 DIMM/CPU and 12 DIMM/CPU population rules using identical modules

In order to configure for memory mirroring, all memory modules must be identical in size, speed, density, and technology (RDIMM vs LRDIMM, etc). Additionally, memory channels must be populated with all one DIMM or all two DIMMs (for example, 24 DIMM systems should have 12 DIMMs or 24 DIMMs installed). Memory mirroring is disabled by default and must be enabled through the BIOS setup menu.

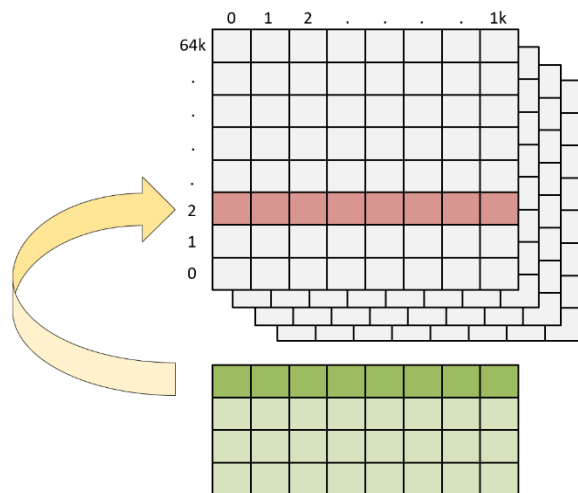
Figure 7 - PPR for a row in a bank group of a 4Gb x4 device

When the server platform determines that a DRAM row has one or more faulty cells, it can instruct the DRAM to electrically swap out the old row and replace it with a new one. This happens through electrical fusing and is a permanent process. Additionally, the PPR process can only occur at the beginning of a boot process – before memory training and test can occur. Similar to Memory Page Retirement, deeming which DRAM require Post Package Repair is determined by a proprietary Dell algorithm that takes into account correctable error rates and error patterns. As of [BIOS versions 2.7.7](#) or higher, self-healing through PPR on consumed uncorrectable errors is also now supported.
